**Petition for the Reconsideration and
Modification of the National
Transportation Safety Board's Findings
and Determination of the Probable Cause
for the Crash of TWA Flight 800**

The TWA 800 Project
6/19/2013

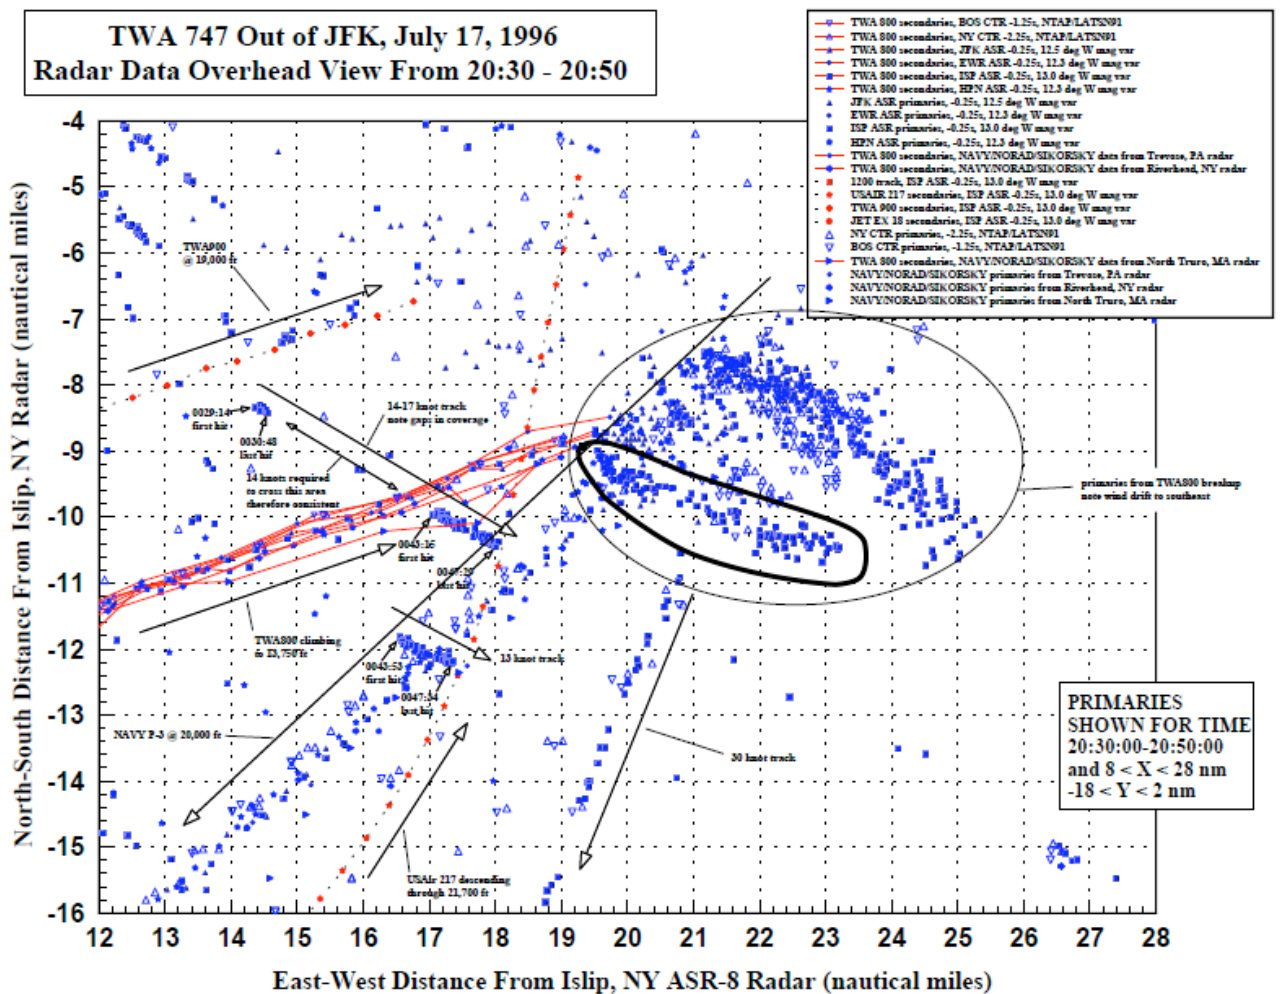
Within 8.5 seconds of TWA Flight 800 losing electrical power, a heavy concentration of light debris began appearing on the FAA radar between 1/3 and 1/2 mile due south of and almost perpendicular to TWA Flight 800's flight path. The majority of this debris stopped most of its horizontal motion and began falling to the ocean 1/2 mile south of where TWA Flight 800 lost electrical power. As it fell to the ocean, the wind carried this debris toward the SE for more than ten minutes. The Islip, White Plains, and JFK radar sites recorded the debris as it fell. When plotted over time, the radar returns from this debris appear as a distinctive, diagonal band, as shown on the NTSB radar plot below.

Figure 1: NTSB radar plot from page 44 of the Airplane Performance Study (Exhibit 13A). The band of debris in question has been circled by the petitioners with a thick black line.

At the 1997 NTSB hearing in Baltimore, NTSB investigator John Clark testified that the above-mentioned plume of radar returns (circled with a thick black line above) was “consistent with the explosion” that caused the crash. However, Mr. Clark did not provide a scientific basis for that conclusion nor did he attempt to further characterize that explosion by presenting an analysis of the subject radar returns. Our analysis of the speed and direction of the circled radar returns presented below demonstrates that the explosion responsible for the propagation of these returns was, in fact, a high velocity explosion--a detonation. The official NTSB theory for the crash is based on the assumption that the explosion in question was a low-velocity explosion or deflagration of fuel-air vapors and therefore cannot account for this radar-recorded detonation.

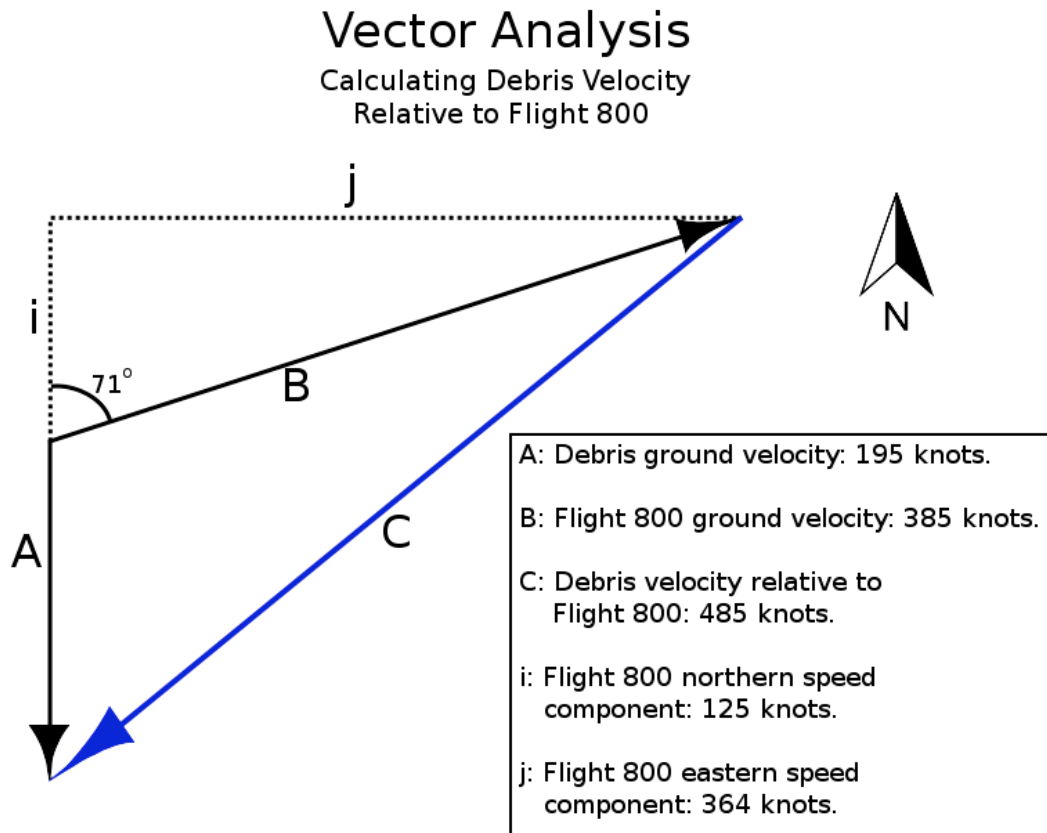
Using the Pythagorean Theorem, the average speed of the debris relative to the accident aircraft was between 463 and 495 knots or between 238 and 255 m/s.

Figure 2: Addition of Flight 800 and debris velocity vectors. The blue line labeled **C** represents the debris' velocity relative to Flight 800. Lines **A** and **B** represent the ground velocities of the debris and Flight 800 respectively. Lines **i** and **j** represent Flight 800's northern and eastern speed components.

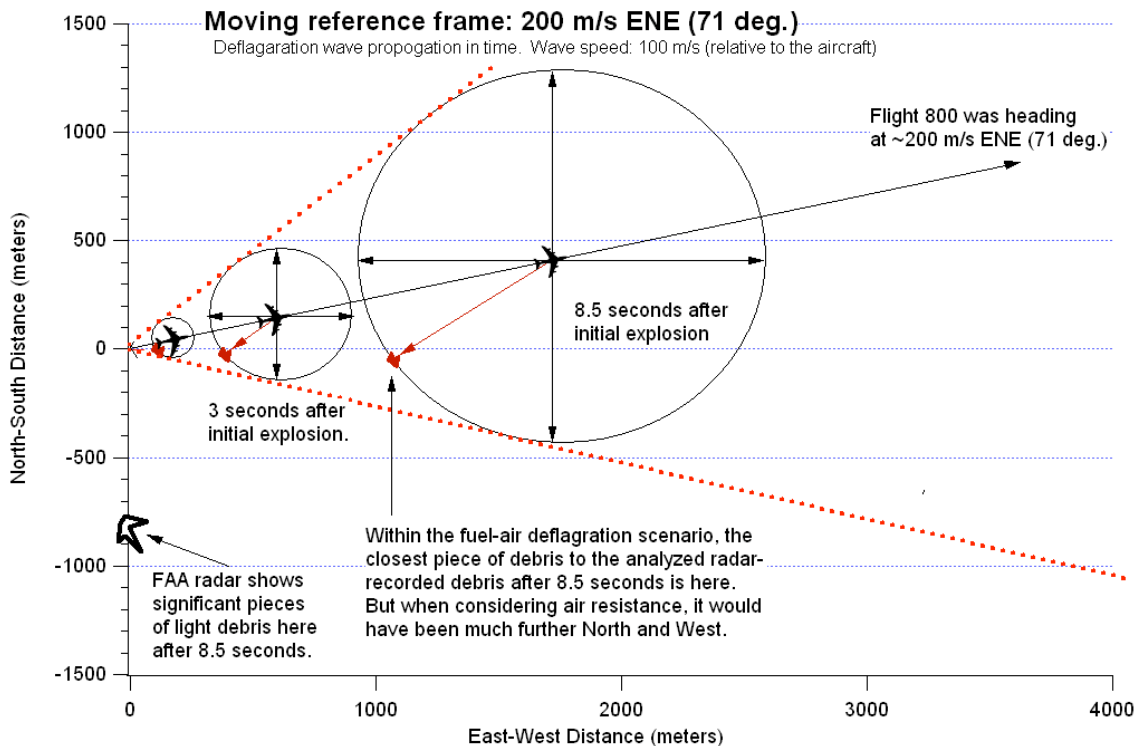
Figure 3: Maximum deflagration wave expansion at three points in time in TWA Flight 800's reference frame. Air resistance is neglected outside the aircraft to provide a best-case scenario for the NTSB's crash sequence. The red arrows point to hypothetical debris ejected by the deflagration. The 747 icons are not to scale.

In Figure 3, the circles represent the maximum expansion of the officially proposed fuel-air deflagration. The red dotted lines represent the maximum horizontal distance any piece of debris could have traveled in the first moments after the explosion. The hypothetical wreckage item colored red at the lower left edge of each circle represents the most dense and streamlined wreckage fragment, since the effects of air resistance would be lowest for such fragments. But as can be seen, even a fragment with those properties would still be more than one kilometer away from where radar sites recorded the debris plume at 8.5 seconds.

Since TWA Flight 800 was traveling about two times faster than the wave propagation speed of the proposed fuel-air deflagration, nothing from that deflagration could have reached the position where radar sites recorded the debris in question, which is represented by a large irregular shape on the left axis of Figure 3, about 800 meters south of the position of the initiation of the explosion. As discussed above in the *Error Analysis* section, the actual position of the debris detected on radar at 8.5 seconds could have been anywhere between approximately 1/3 and 1/2 of a nautical mile due south of the explosion, or between 700 and 1000 meters south of the explosion.

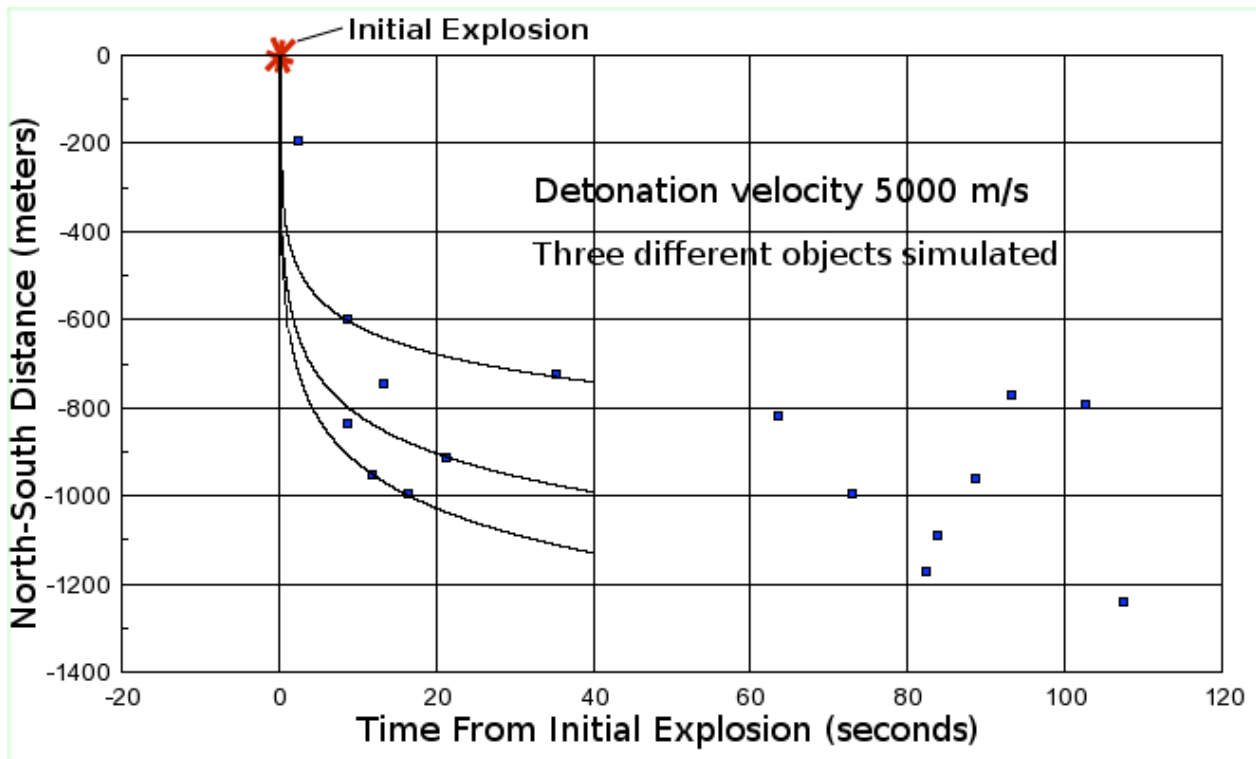
Figure 4: Three ballistics curves fit to north-south position vs. time from the Islip and White Plains radar sites. This plot only shows the north-south distances and speeds. Flight 800 was heading ENE at 385 knots. The small blue squares are a composite of Islip and White Plains FAA radar returns.

ejected from the initial explosion and each would have different inertial and aerodynamic properties. Three ballistics curves fit the data well, each with exit velocities greater than Mach 4 (four times the speed of sound). Curves with exit velocities below Mach 4 and with low drag forces relative to their mass would not decelerate fast enough to fit the data. Curves with high drag forces relative to their mass and with exit velocities less than Mach 4 would not reach the earliest and southern-most debris recorded by radar.
